Your New Home Lane
Your Place, USA 22222

Prepared for: New Home Owner

Prepared by: Strategic Enterprises, LLC

Definitions

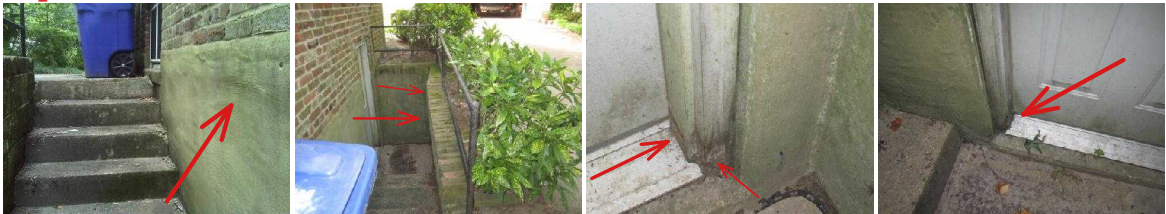
- 5. Defective Basement Stairwell: Concrete- -- Railings missing. Wall deteriorating and bowing in. Door frame has rotted wood. A qualified contractor is recommended to evaluate and estimate repairs.

2. **Basement Stairwell: Concrete-** -- Railings missing.
Wall deteriorating and bowing in.
Door frame has rotted wood.
A qualified contractor is recommended to evaluate and estimate repairs.

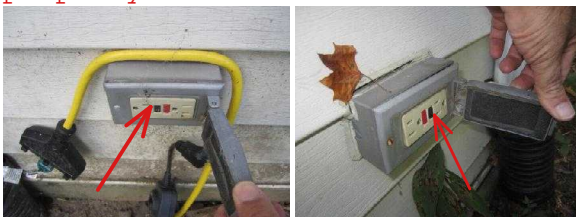
- 8. Acceptable Basement Windows: Vinyl
- 9. Acceptable Exterior Lighting: Surface mount-
- 10. Defective Exterior Electric Outlets: 110 VAC GFCI- -- GFCI outlet is not functioning properly.

9. **Exterior Electric Outlets: 110 VAC GFCI-** -- GFCI outlet is not functioning properly.

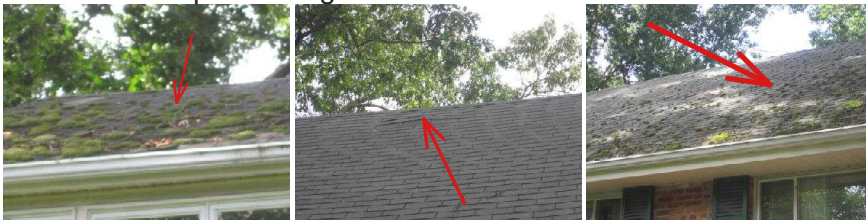
- 1. Method of Inspection: Ground level
- 2. Acceptable Unable to Inspect: 10%
- 3. Defective Material: Asphalt shingle- -- **Roof near end of useful life. Trim trees back.**

10. Main Roof Surface Material: Asphalt shingle- -- Roof near end of useful life. Trim trees back.

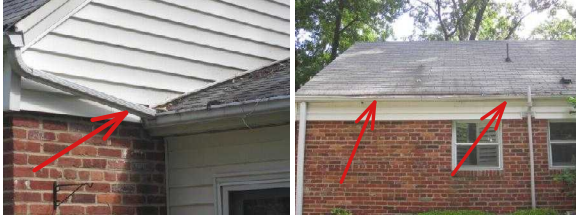
- 12. Defective Gutters: Aluminum- -- **Rear gutter not properly drained. Install down spout to an existing drain.**
Clogged, Gutters loose, spikes or straps missing

13. Gutters: Aluminum- -- Rear gutter not properly drained. Install down spout to an existing drain.

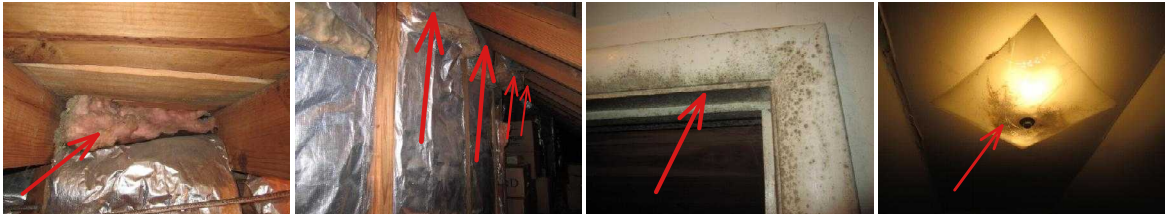
- 1. Method of Inspection: From the attic access
- 2. Acceptable Unable to Inspect: 70%-
- 3. Acceptable Roof Framing: 2x4 Rafter
- 4. Acceptable Sheathing: Dimensional wood-
- 5. Defective Ventilation: soffit & gable -- Insufficient ventilation.
Rafter bays blocked with insulation.
Gable vents too small.
Moisture evidence in upstairs. A qualified roofing contractor is recommended to evaluate and estimate repairs.

18. Main Attic Ventilation: soffit & gable -- Insufficient ventilation.

Rafter bays blocked with insulation.

Gable vents too small.

Moisture evidence in upstairs. A qualified roofing contractor is recommended to evaluate and estimate repairs.

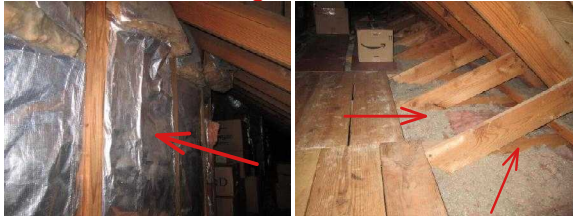
- 6. Acceptable, Defective Insulation: Batts-, Blown in- -- **Installed Backwards. Vapor barrier should face conditioned space. Recommend adding additional insulation to a value of R25 or greater as appropriate.**

19. Main Attic Insulation: Batts-, Blown in- -- Installed Backwards. Vapor barrier should face conditioned space.

Recommend adding additional insulation to a value of R25 or greater as appropriate.

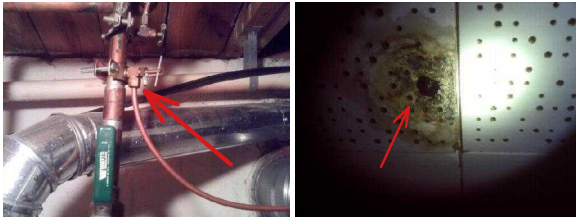
- 1. Acceptable Service Line: Copper-
- 2. Acceptable Main Water Shutoff: Basement
- 3. Defective Water Lines: Copper- -- Leak at water heater saddle valve. Leaks in water line running down center of basement.

26. Water Lines: Copper- -- Leak at water heater saddle valve. Leaks in water line running down center of basement.

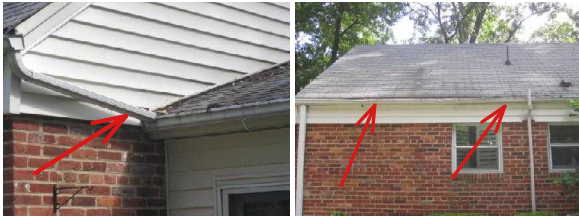
Clogged, Gutters loose, spikes or straps missing
